Thank you for purchasing this evaporator kit from Vintage Air. When installing these components as part of a complete SureFit[™] system, Vintage Air recommends working from front to back on the vehicle, installing the condenser kit, hose kit, and compressor first, followed by the wiring, evaporator, and finally the control panel.

A/C Hose Installation

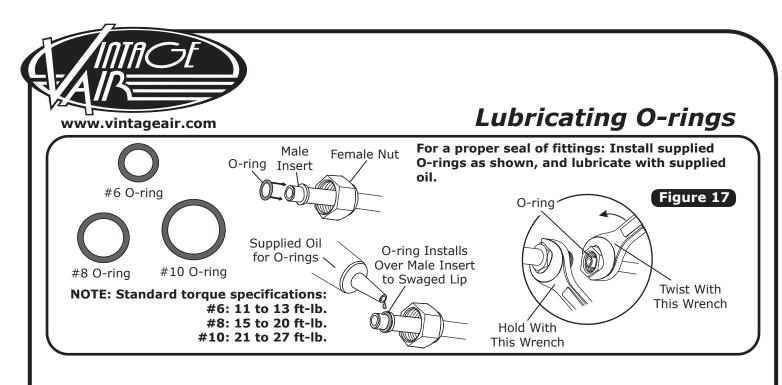
- Locate the #8 compressor A/C hose. Lubricate (2) #8 O-rings (See Figure 17, above) and connect the #8 135° fitting with service port to the #8 discharge port on the compressor (See Figure 19, Page 17). Then route the 45° fitting to the #8 condenser hardline coming from under the radiator core support (See Figure 19, Page 17). Tighten each fitting connection as shown in Figure 17, above.

- 2. Locate the #10 compressor A/C hose. Lubricate (2) #10 O-rings (See Figure 17, above) and connect the #10 135° fitting with service port to the #10 suction port on the compressor (See Figure 19, Page 17). Then route the 45° fitting to the #10 evaporator hardline coming through the firewall (See Figure 18, Page 16). Tighten each fitting connection as shown in Figure 17, above.

- **3.** Locate the #6 evaporator hardline. Lubricate (2) #6 O-rings (See Figure 17, above) and connect the hardline to the #6 hardline coming under the radiator core support from the drier (See Figure 19, Page 17). Then route the other end of the hardline with lubricated O-ring to the #6 evaporator hardline coming through the firewall (See Figure 18, Page 16). Tighten each fitting connection as shown in Figure 17, above.

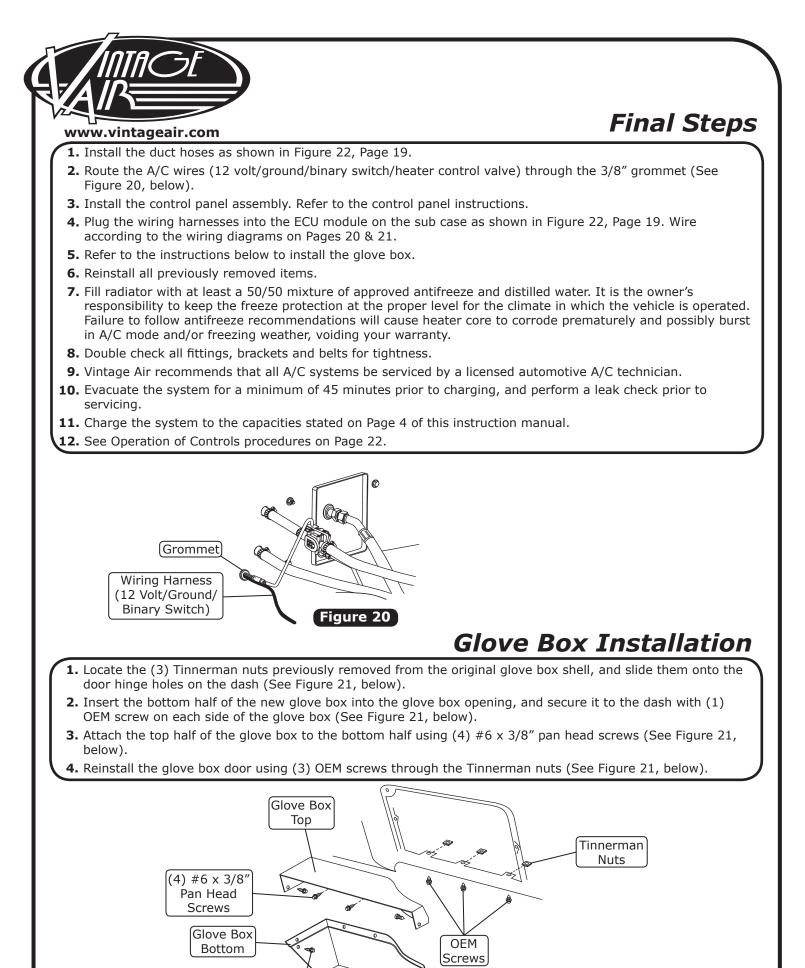
Figure 21

OEM

Screws

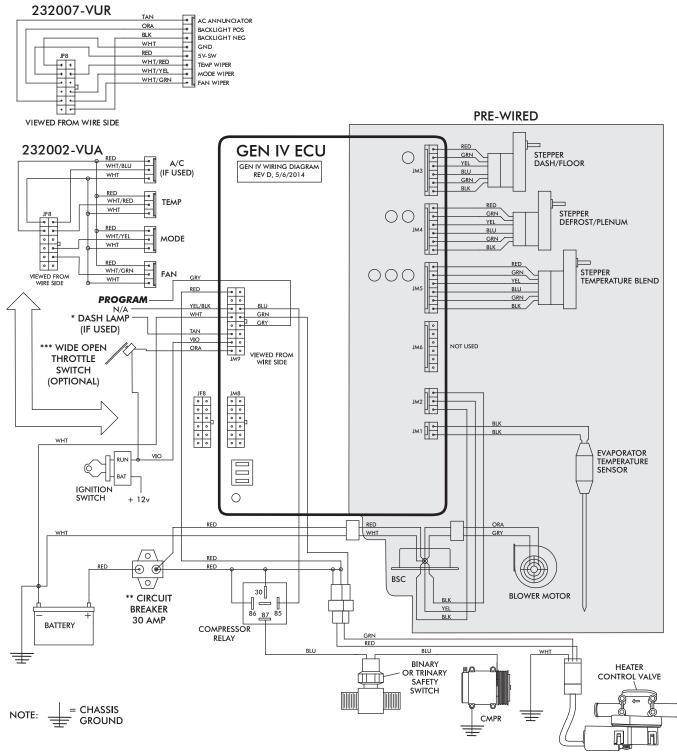
Wiring Diagram

- Dash Lamp Is Used Only With Type 232007-VUR Harness.
- Warning: Always Mount Circuit Breaker As Close to the Battery As Possible. (NOTE: Wire Between Battery and Circuit Breaker Is Unprotected and Should Be Carefully Routed to Avoid a Short Circuit).
- Wide Open Throttle Switch Contacts Close Only at Full Throttle, Which Disables A/C Compressor.
